ACID MINE DRAINAGE ABATEMENT IN THE LOWER ROCK CREEK WATERSHED – McCREARY COUNTY, KENTUCKY

Mark B. Carew, Kentucky Division of Abandoned Mine Lands, 2521 Lawrenceburg Road,
Frankfort, Kentucky 40601

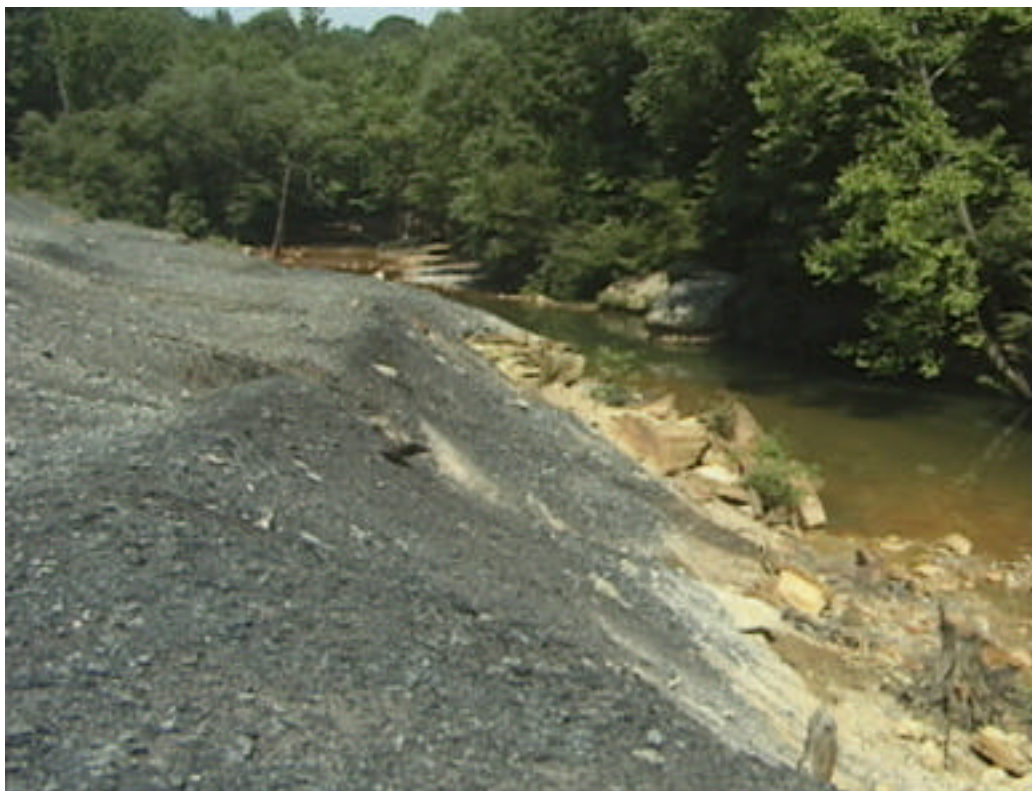
Figure 10. Water Tank Hollow Refuse Area before reclamation.

The Water Tank Hollow site was a 3-acre coal processing refuse disposal site on the north bank of Rock Creek (Fig. 10). This project involved the removal of 20,000 cubic yards of highly acidic coal mine refuse from the Water Tank Hollow site and the removal of 5,000 cubic yards of refuse from the Paint Cliff site. The refuse was hauled to an existing sparsely vegetated fill area in Roberts Hollow, treated with agricultural limestone at rates determined by soil testing, and placed in compacted lifts (Fig. 11). The computer programs SEDCAD4 and RUSLE were used to calculate the soil/refuse loss from the Water Tank Hollow refuse site each year. It was calculated that the annual soil/refuse loss was about 500 tons per year. The refuse was sampled and found to have a potential acidity of 165 tons CaCO_3 per kiloton of refuse. Removal of the refuse from the Water Tank Hollow site resulted in a reduction of 82.5 tons of acidity per year from the direct washing of the refuse into the stream. The actual acid load reduction is higher due to the formation of sulfur salts in the refuse and subsequent dissolution and runoff of acid into the stream during precipitation events. It was not possible to directly monitor the acid runoff at this site due to the nonpoint source nature of the three acres of acidic refuse located on the north bank of Rock Creek.

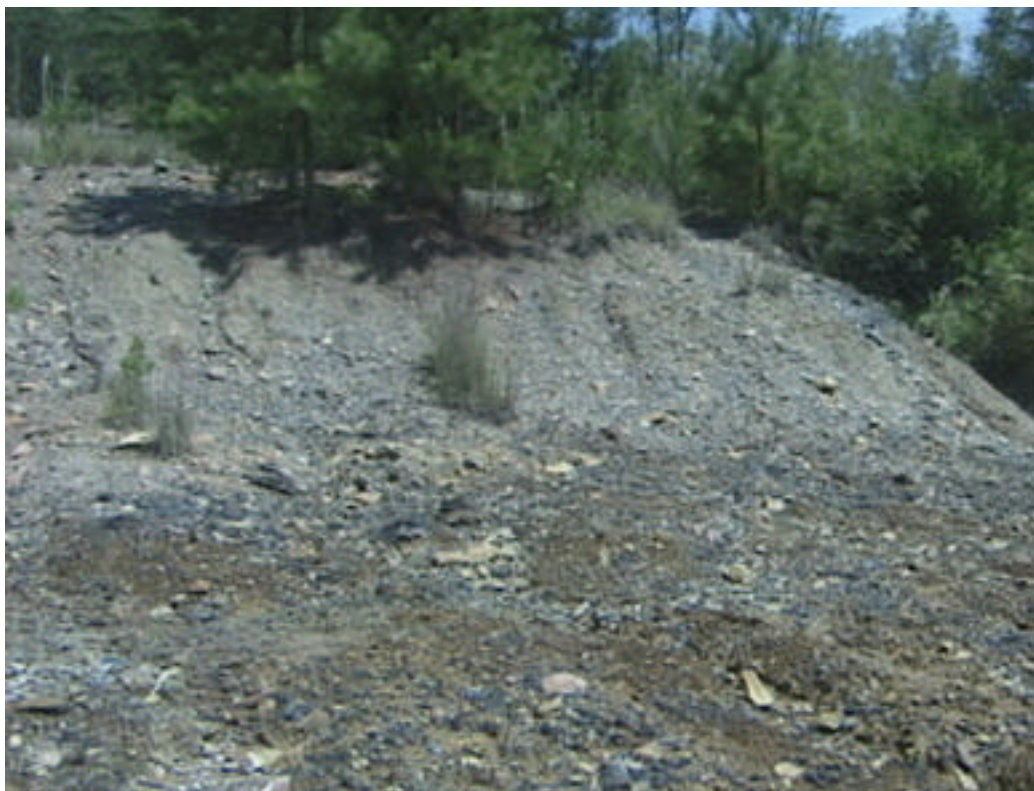
Figure 11. Roberts Hollow Refuse Fill Area before reclamation.

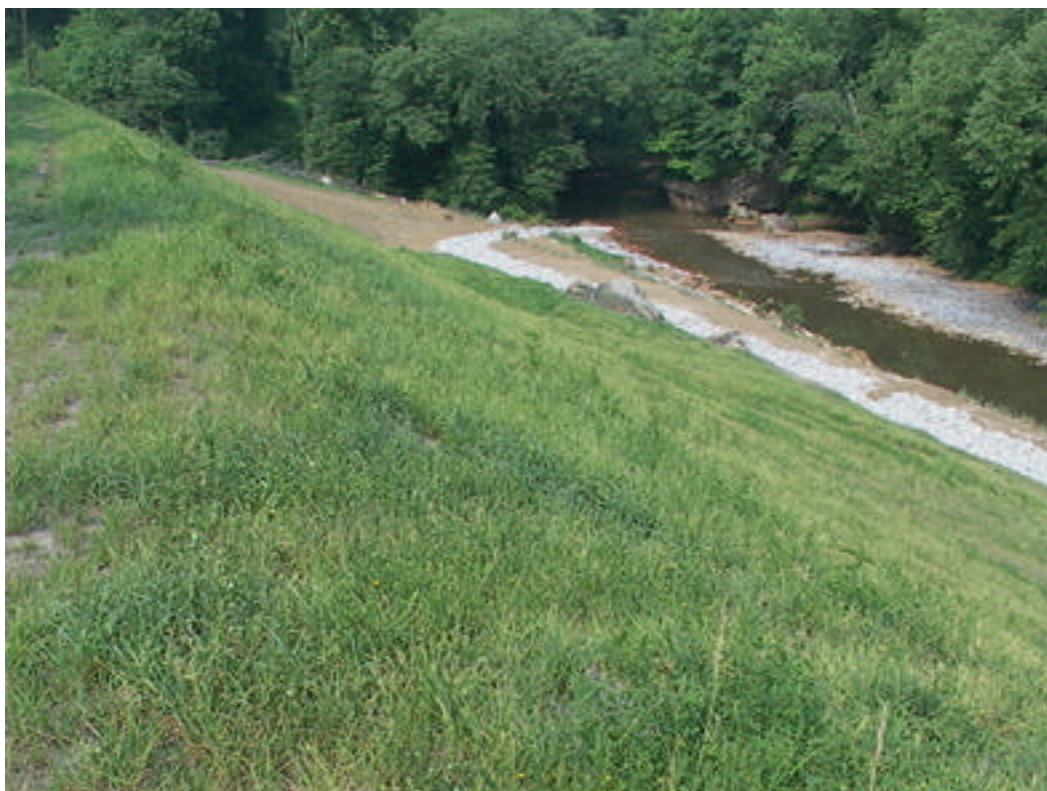
Figure 12. Water Tank Hollow Refuse Area after reclamation.

After removal of the refuse from the Water Tank Hollow and Paint Cliff sites the slopes were graded to a smooth uniform configuration. After placement of the fill at Roberts Hollow two feet of soil cover was placed over the refuse. Agricultural limestone was added to the sites and tracked in with a bulldozer. The sites were fertilized, seeded, mulched, and netted. The sites were revegetated with a mix of warm and cool season grasses, legumes, and trees compatible with the surrounding vegetation (Figs. 12, 13)

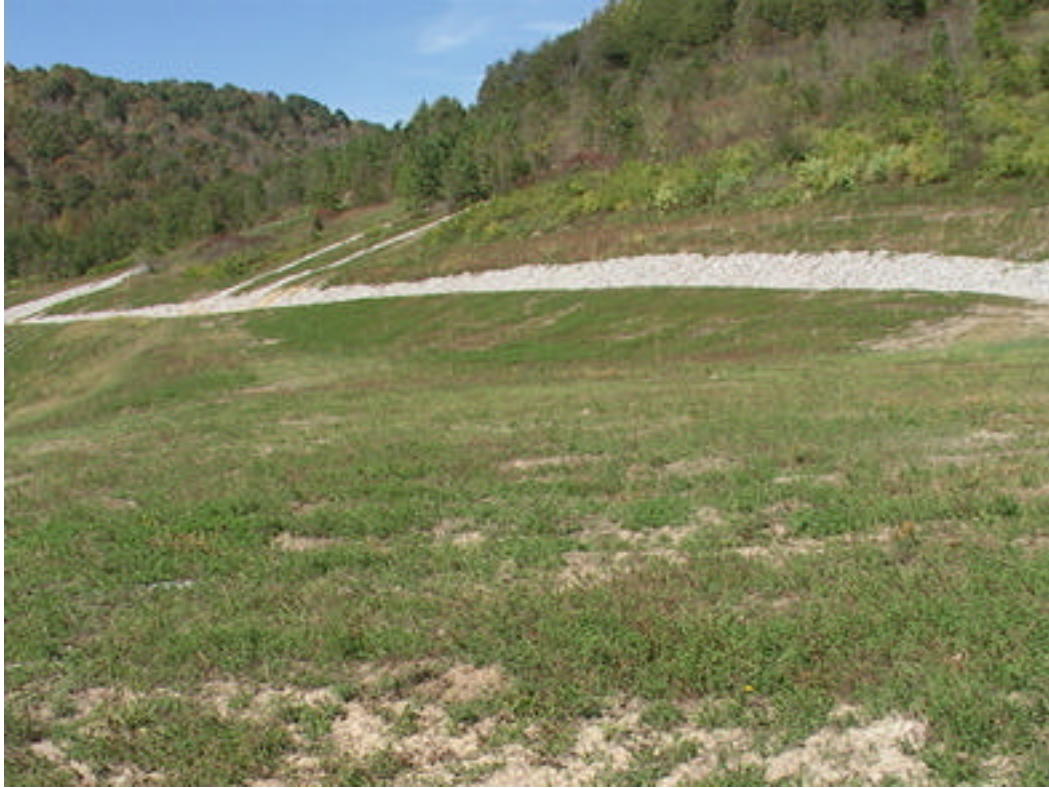
Figure 13. Roberts Hollow Refuse Fill Area after reclamation.
